# **INDOOR AIR QUALITY ASSESSMENT**

**South Middle School  
232 Peach Street  
Braintree, Massachusetts**

Prepared by:  
Massachusetts Department of Public Health  
Bureau of Environmental Health Assessment  
July, 2002

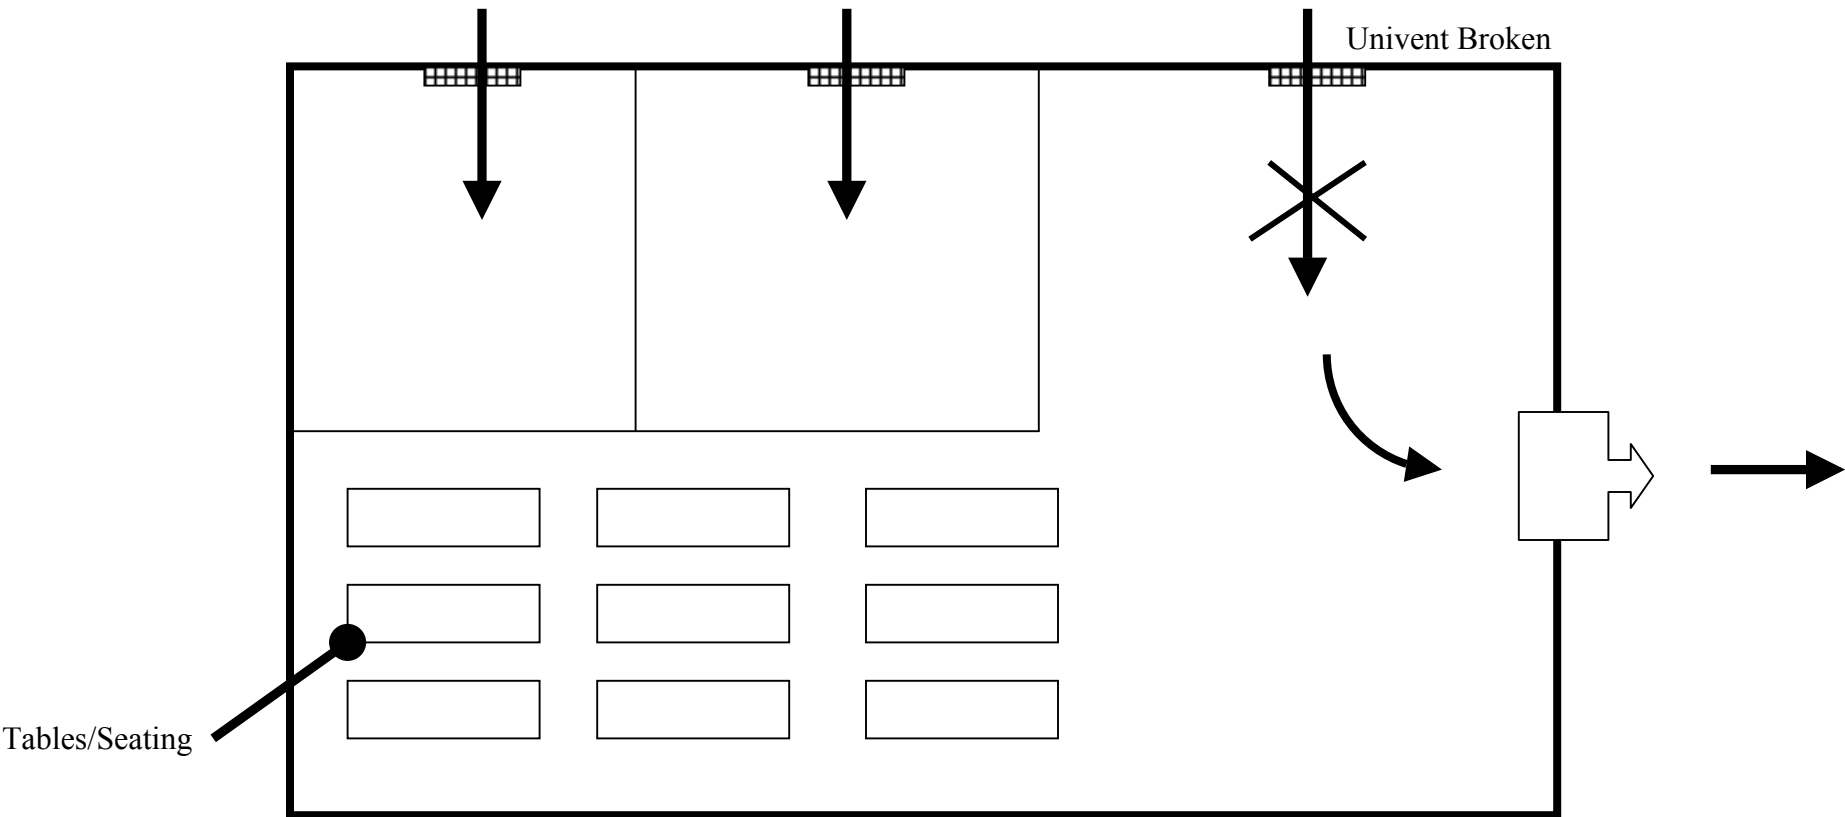
Figure 3

Supply ventilation in the cafeteria was designed to be provided by three univents along the exterior wall (see Figure 2). Two classrooms were constructed within the cafeteria, which enclosed two of the three univents. The cafeteria ventilation was reduced by two-thirds of its design capacity with this alteration (see Figure 3). In addition, the one remaining univent was not functioning at the time of the assessment. School officials reported that a replacement motor was on order for this unit. Further reducing cafeteria air circulation is the location of the exhaust vent in relation to the univent (see Picture 2). As air is introduced by the univent it tends to be directed out of the cafeteria via the exhaust vent (called short-circuiting). This configuration would limit

the distribution of air to the occupied areas of the cafeteria where occupants sit (see Figure 3).

Current Cafeteria Configuration of Mechanical Ventilation and Airflow

2. Work with HVAC engineer to provide adequate ventilation to the cafeteria and added classrooms.
3. Thermostat settings throughout the school should be evaluated. Repair/replace thermostats as necessary. Thermostats should be set at temperatures to maintain comfort for building occupants.

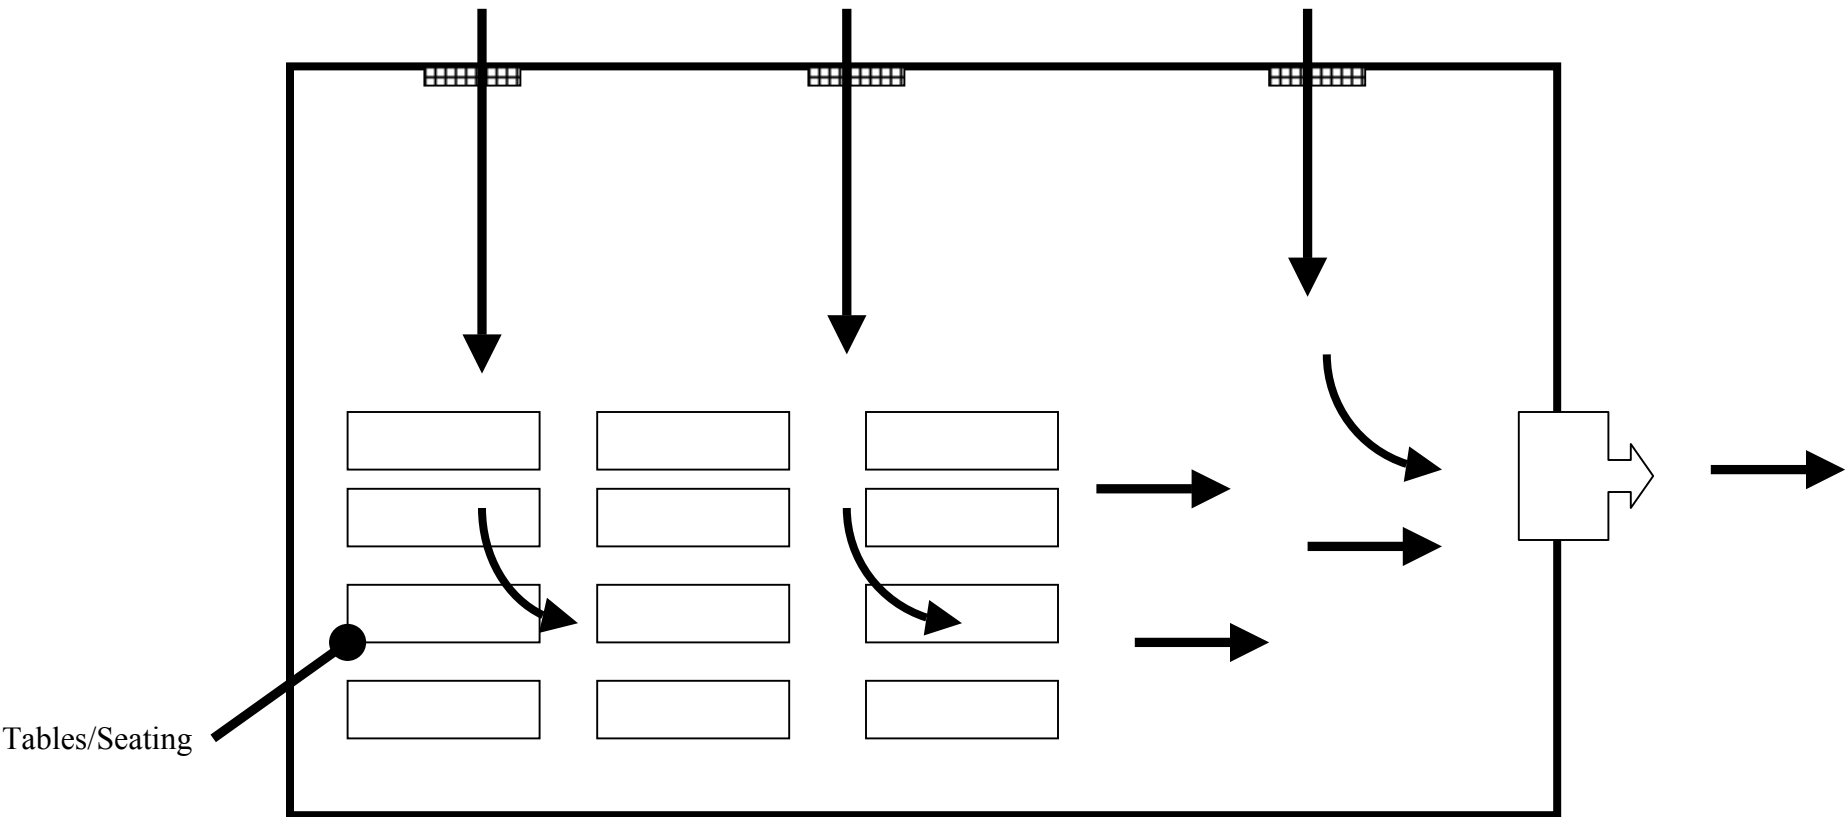
Figure 2

Original Cafeteria Configuration of Mechanical Ventilation and Airflow

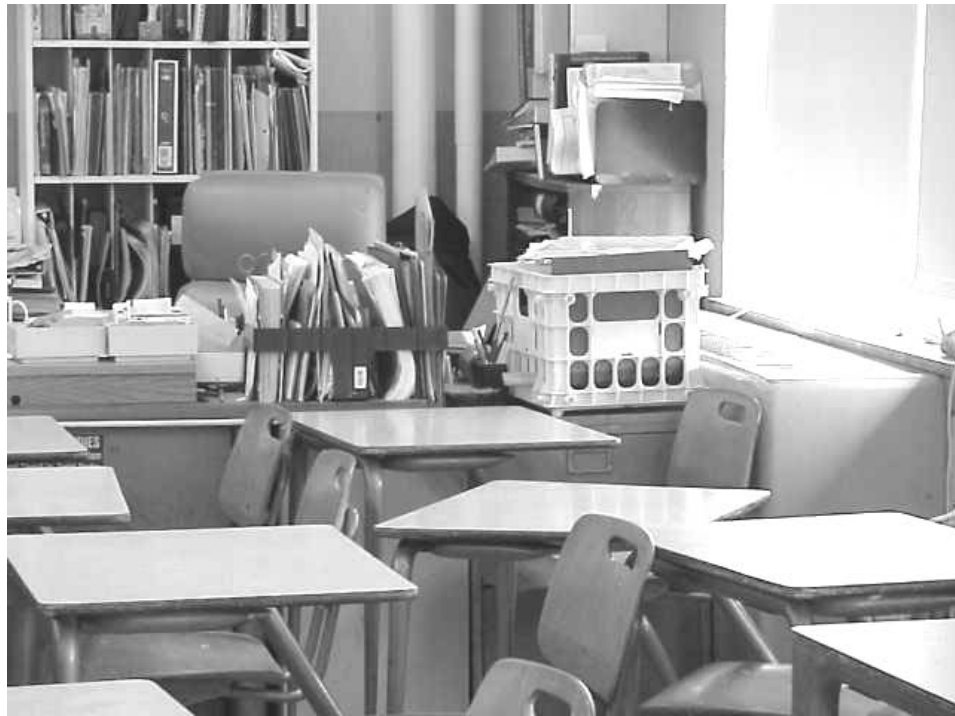
**Picture 1**

It can be seen from the tables that carbon dioxide levels were elevated above 800 parts per million parts of air (ppm) in twenty-one out of fifty-five areas surveyed, indicating a ventilation problem in some areas of the school. Fresh air in classrooms is supplied by a unit ventilator (univent) system. Univents draw air from outdoors through a fresh air intake located on the exterior walls of the building and return air through an air intake located at the base of each unit (see [Figure 1](#)). Fresh and return air are mixed, filtered, heated and provided to classrooms through a fresh air diffuser located in the top of the unit. Obstructions to airflow, such as papers and books stored on univents and bookcases, carts and desks in front of univent returns were seen in a number of classrooms (see Picture 1). The univent in the media center contained accumulated dirt/debris. This univent should be cleaned before operating to prevent aerosolization of this material. In order for univents to provide fresh air as designed, intakes must remain free of obstructions and allowed to operate while rooms are occupied.

**Items in Classroom Obstructing Univent Airflow**

1. To maximize air exchange, the BEHA recommends that both supply and exhaust ventilation operate continuously during periods of school occupancy independent of classroom thermostat control.
2. Examine each univent for function. Continue with plans to repair cafeteria univent. Survey classrooms for univent function to ascertain if an adequate air supply exists for each room. Operate fresh air supply univents while classrooms are occupied. Consider consulting a heating, ventilation and air conditioning (HVAC) engineer concerning the calibration of univent fresh air control dampers school-wide.
3. Set the thermostats for modular classrooms to the fan “on” position to operate the ventilation system constantly during the school day.
4. Inspect exhaust motors and belts for proper function, repair and replace as necessary.
5. Remove all blockages from univents and exhaust vents.

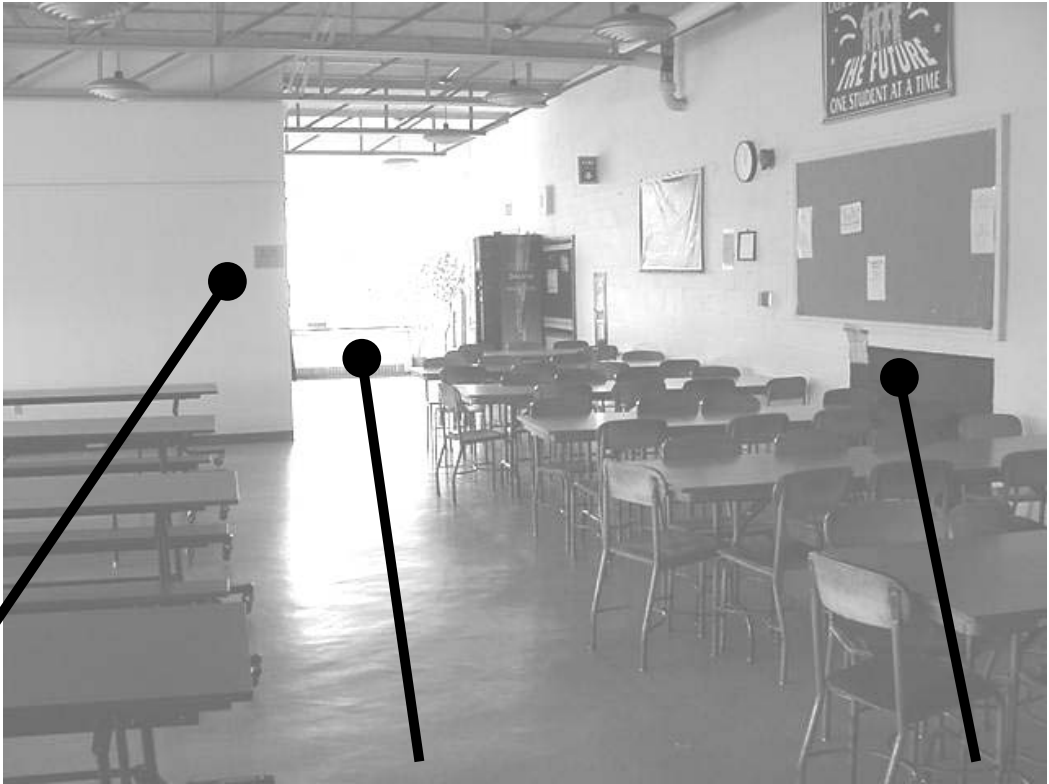
Picture 2

added classrooms                      cafeteria univent (one of three original units)                      cafeteria exhaust vent

**Longview of Current Cafeteria Configuration**

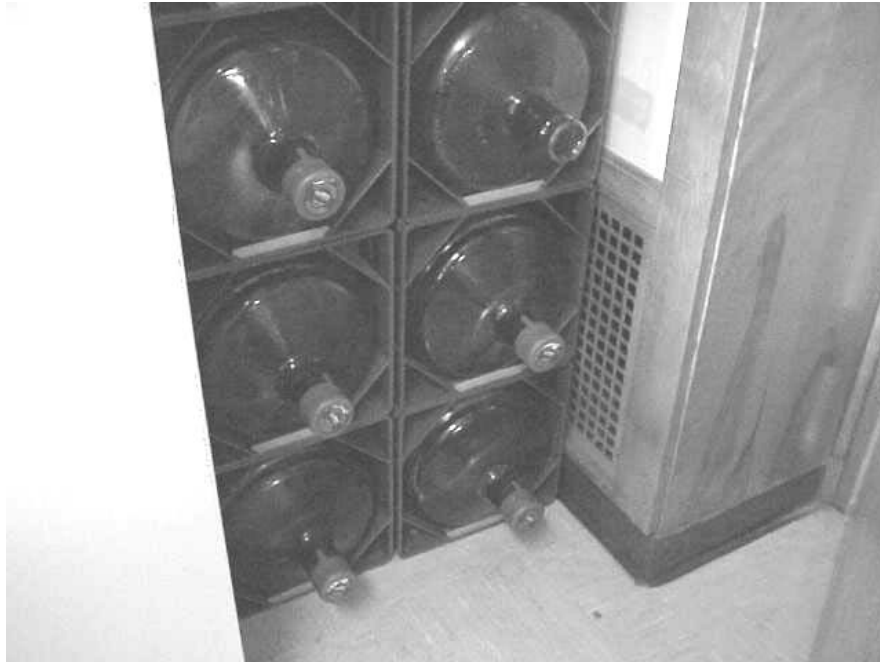
**Picture 3**

Exhaust ventilation in general classrooms with univents is provided by a mechanical system. The exhaust system in each classroom consists of ducted, grated wall vents. Exhaust ventilation operates continuously. Exhaust vents were blocked by various items in many areas (see Picture 3). In order for exhaust ventilation to function as designed, vents must remain free of obstructions.

**Classroom Exhaust Vent Obstructed by Water Bottles/Crates**

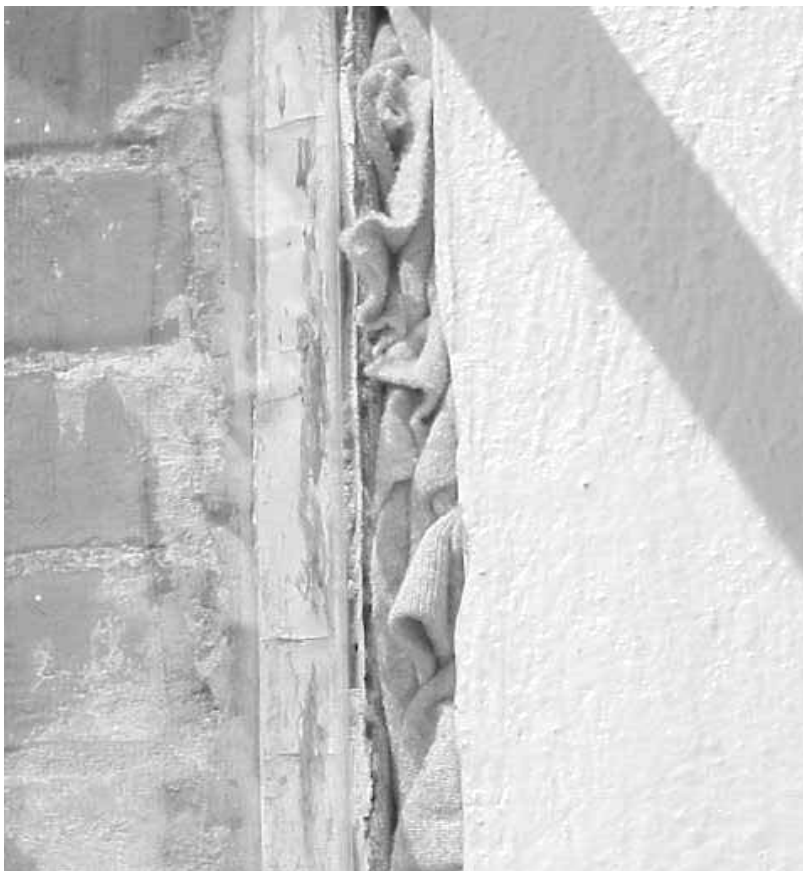
**Picture 4**

**Towel Stuffed between Window Frame in Classroom**

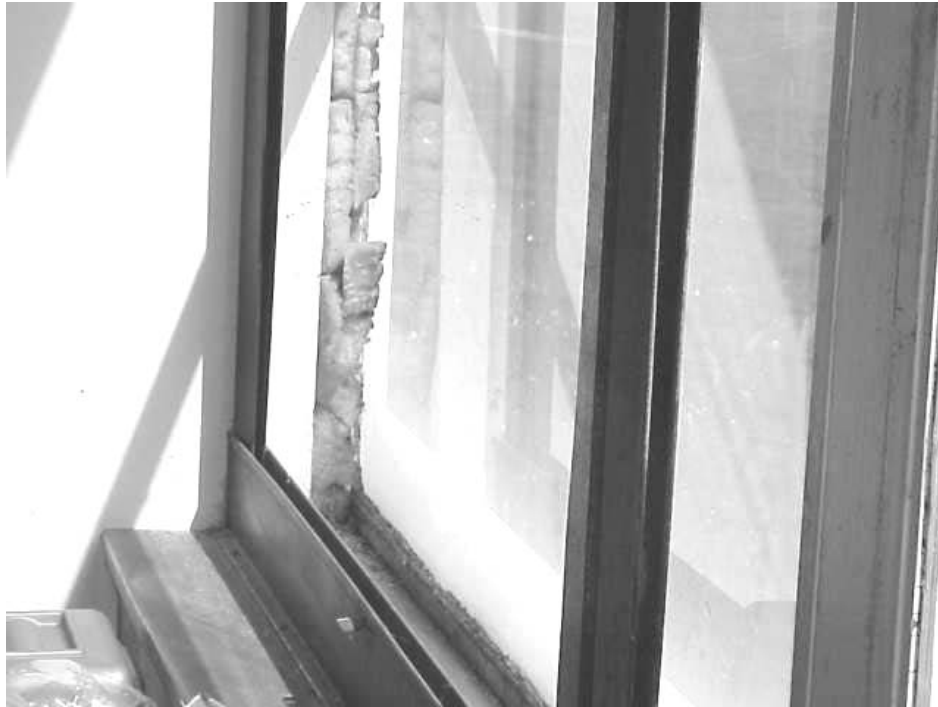
**Picture 5**

**Fiberboard Stuffed between Window Frame in Classroom**

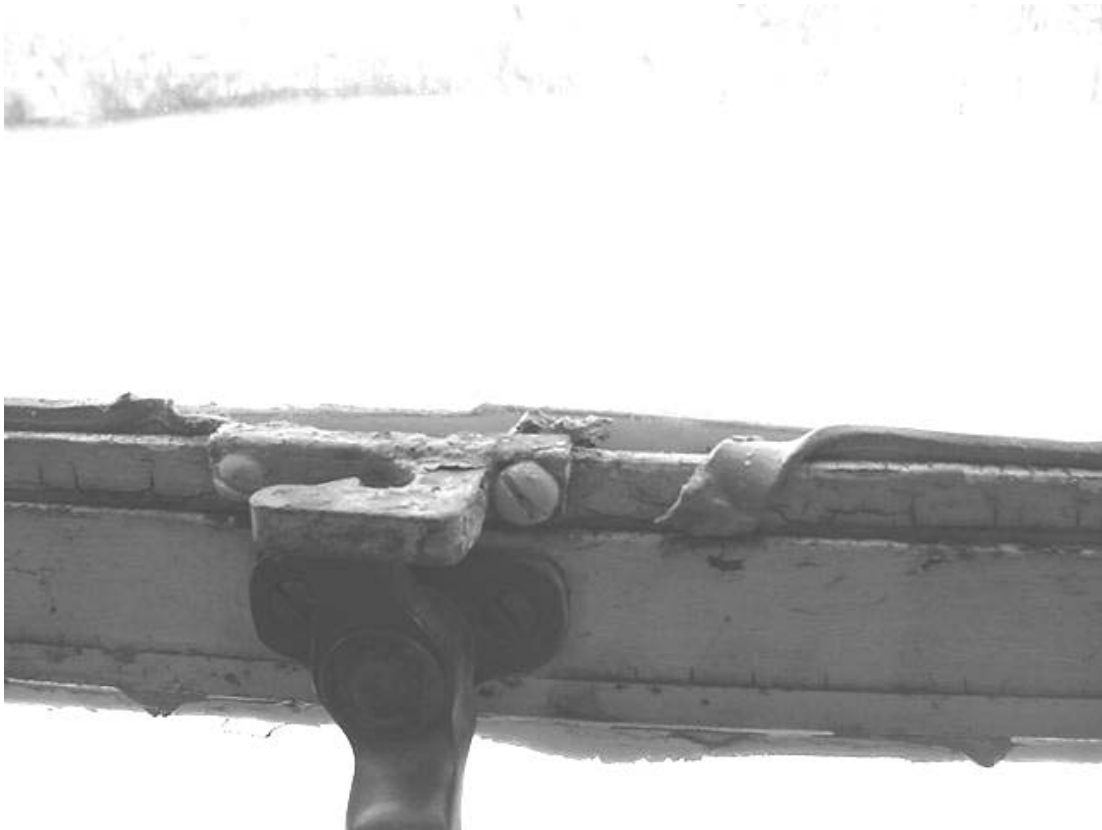
**Picture 6**

Caulking around windows (interior and exterior) was crumbling/damaged throughout the building indicating that the water seal is no longer intact (see Pictures 6 & 7). Several areas had broken windows or windows replaced with plywood (see Picture 8). Water penetration through damaged window frames can lead to mold growth under certain conditions. In addition, towels used to soak up water around windows (see Picture 4) and other porous materials can serve as mold growth mediums. Replacement of caulking and repairs of window leaks are necessary to prevent water penetration.

**Missing/Damaged Window Caulking in Classroom**

4. Consider having windows replaced or proper flashing installed to prevent further water intrusion. Repair water damaged windowsills, walls and other building materials. Examine these areas for mold growth. Disinfect areas of water leaks with an appropriate antimicrobial.

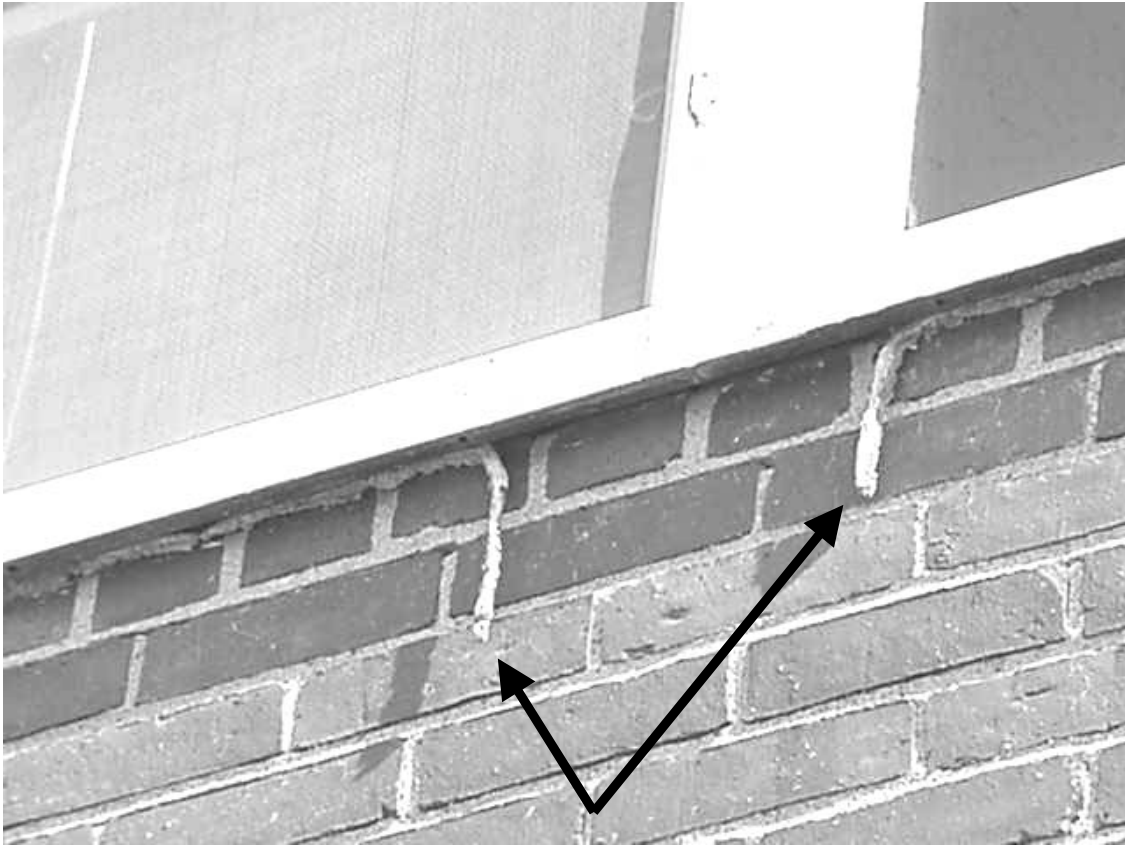
**Picture 7**

**Failing Caulking around Exterior Window Frames**

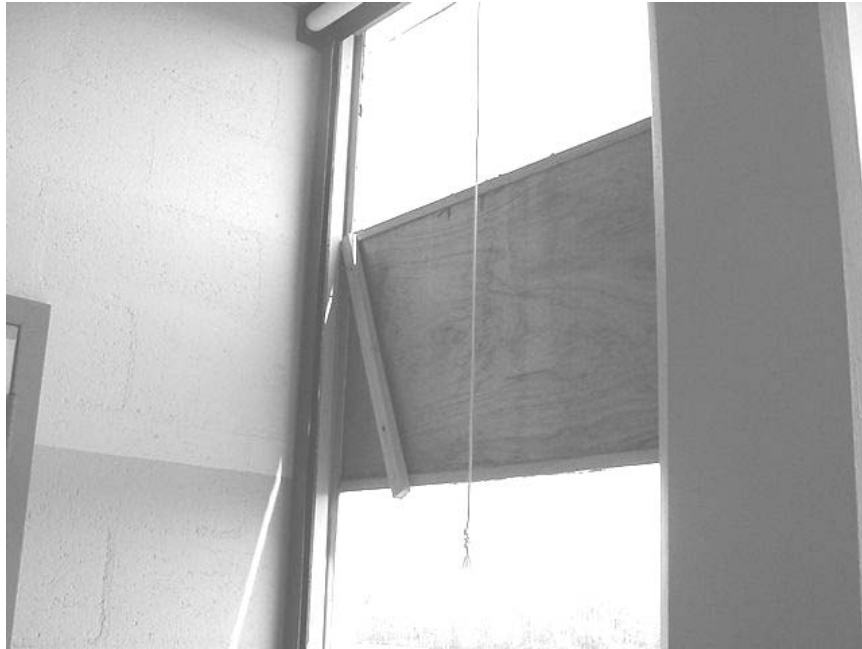
**Picture 8**

**Broken Window Replaced with Plywood**

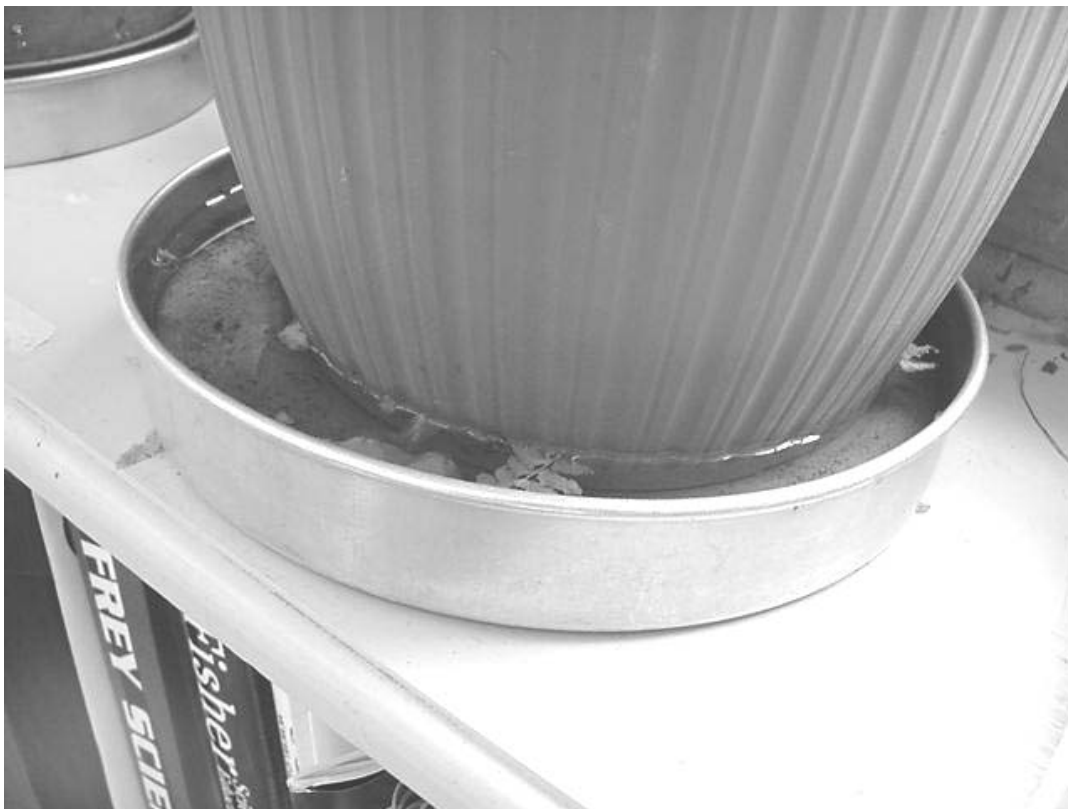
**Picture 9**

Several classrooms contained a number of plants. Plant soil and drip pans can serve as sources of mold growth. One classroom contained a plant in standing water (see Picture 9), which can become stagnant giving off unpleasant odors. Plants should also be located away from univents to prevent aerosolization of dirt, pollen or mold.

**Plant in Standing Water**

9. Ensure all plants are equipped with drip pans. Avoid over watering, examine drip pans periodically for mold growth and disinfect with an appropriate antimicrobial where necessary. Consider reducing the number of plants.

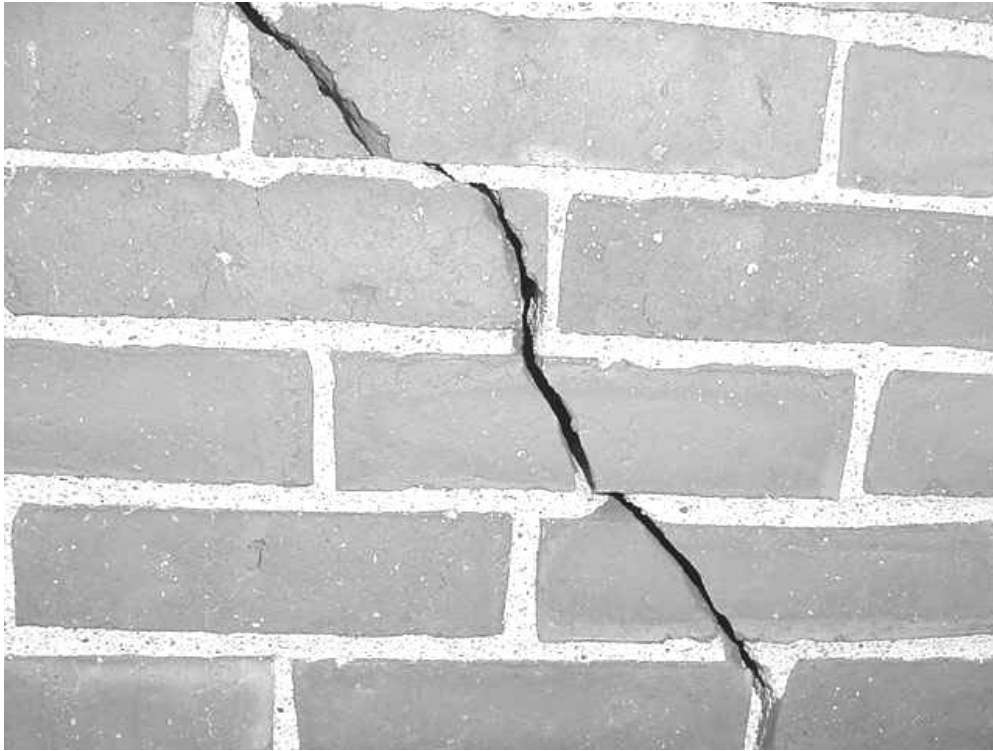
**Picture 10**

The exterior walls had spaces/cracks in brickwork. In many areas mortar around exterior brickwork appears to be crumbling or missing (see Pictures 10 & 11). These conditions are breaches of the building envelope and provide a means for water entry into the building. Repeated water penetration can result in the chronic wetting of building

materials and the potential for microbial growth. In addition large spaces may provide a means of egress for pests/rodents into the building. Signs of efflorescence were noted on walls and around windows. This is caused by water penetration through brick, dissolving minerals within the brick as it flows through. The water evaporates leaving a dry white residue known as efflorescence.

**Crack/Fissure in Exterior Brickwork**

5. Consider having exterior brick repointed. Consult a building engineer for best method to repair damaged exterior brick, which may include waterproofing to

prevent further water intrusion. Repair/replace water-damaged building materials.

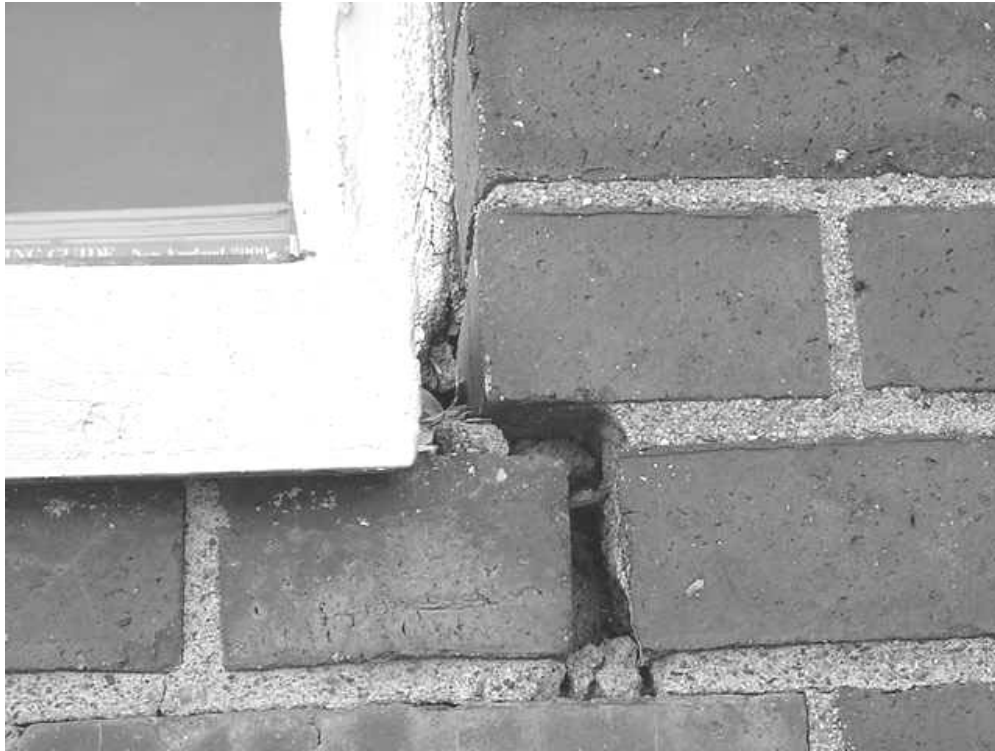
**Picture 11**

**Missing/Damaged Mortar around Window Frame**

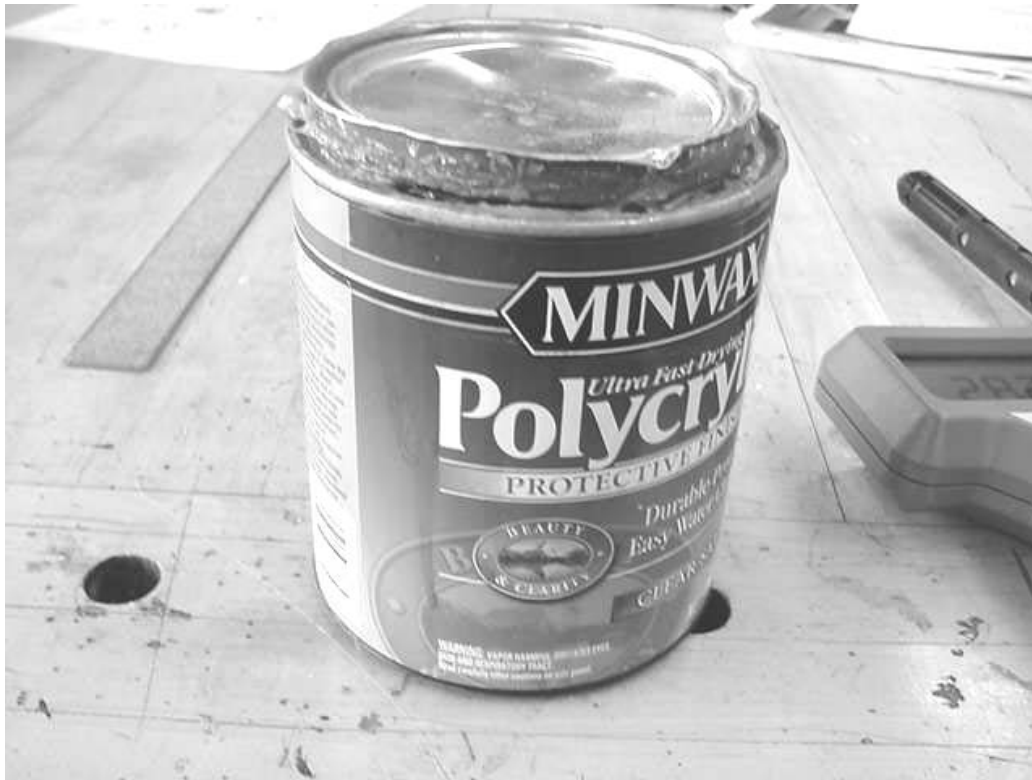
**Picture 12**

Several other conditions were noted during the assessment, which can adversely affect indoor air quality. Open cans of acrylic paint were found in the wood shop (see Picture 12). This material contains volatile organic compounds (VOCs) that can be irritating to the eyes, nose and throat. In addition, the warning label claimed it is a highly flammable material. This material should be properly sealed and stored in a flammables storage cabinet that meets the specifications of the NFPA (NFPA, 1996).

**Open Can of Acrylic Paint in Woodshop**

13. Remove cans of acrylic paint from the woodshop and dispose of in a manner consistent with state hazardous waste disposal law. Consider discontinuing usage of this material in a classroom environment.
14. Clean chalkboards and trays regularly to avoid the build-up of excessive chalk dust. Empty pencil sharpeners regularly, keep immediate area clean of pencil shavings and associated debris.
15. Refrain from using strong scented materials (e.g., air fresheners) in classrooms.

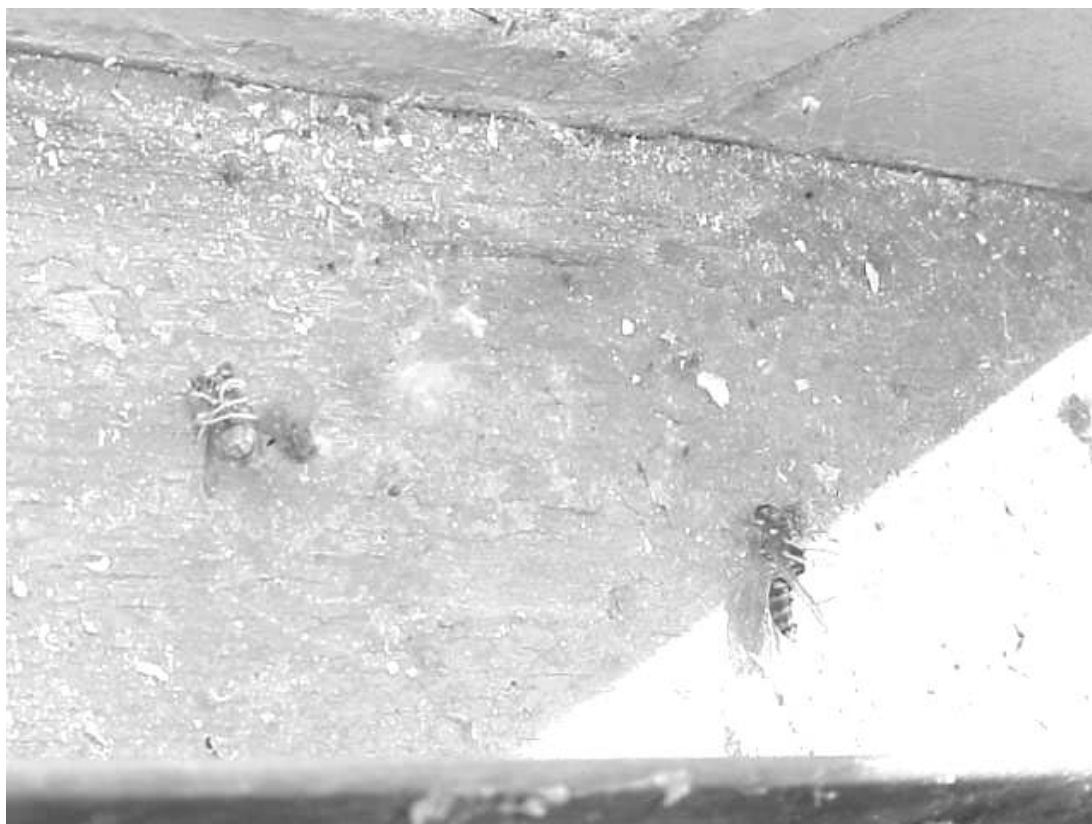
**Picture 13**

The building showed signs of insect infestation. Insect bodies were noted on windowsills in classrooms (see Picture 13). A wasp's nest was noted on the exterior of the building (see Picture 14). Insect parts can become dried out and aerosolized and may serve as a source of allergenic material for sensitive individuals. A combination of cleaning, sealing window systems and increasing ventilation and filtration should serve to reduce insect associated allergens once the infestation is eliminated.

**Insect Bodies on Windowsill in Classroom**

12. It is highly recommended that the principles of integrated pest management (IPM) be used to rid this building of pest. A copy of the IPM recommendations are included with this report as Appendix II (MDFA, 1996).

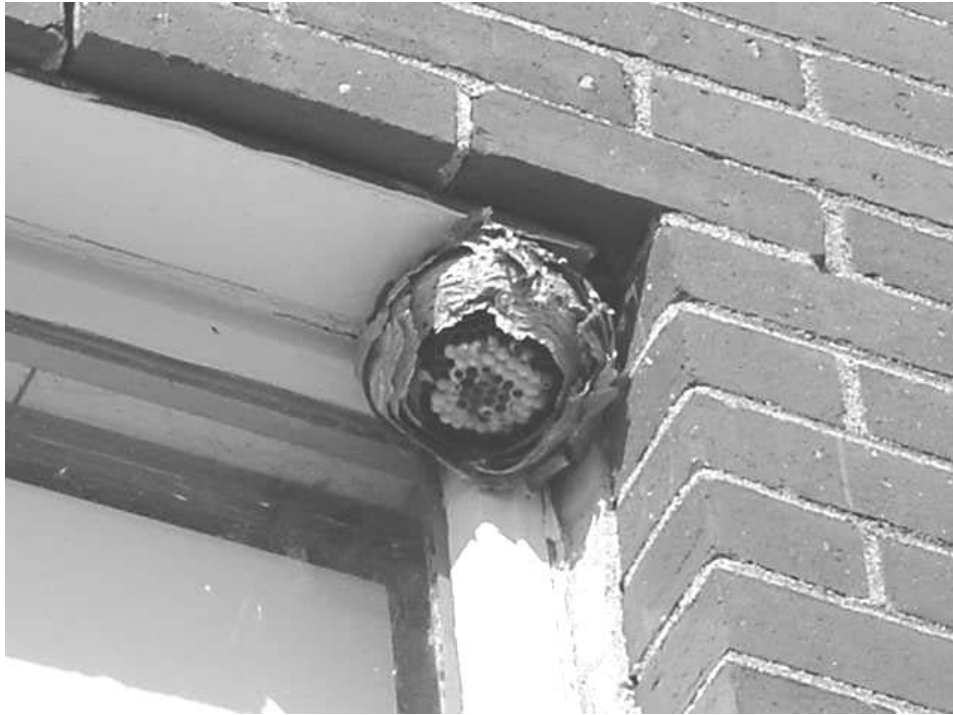
**Picture 14**

**Wasps/Hornets Nest Exterior near Window Frame**

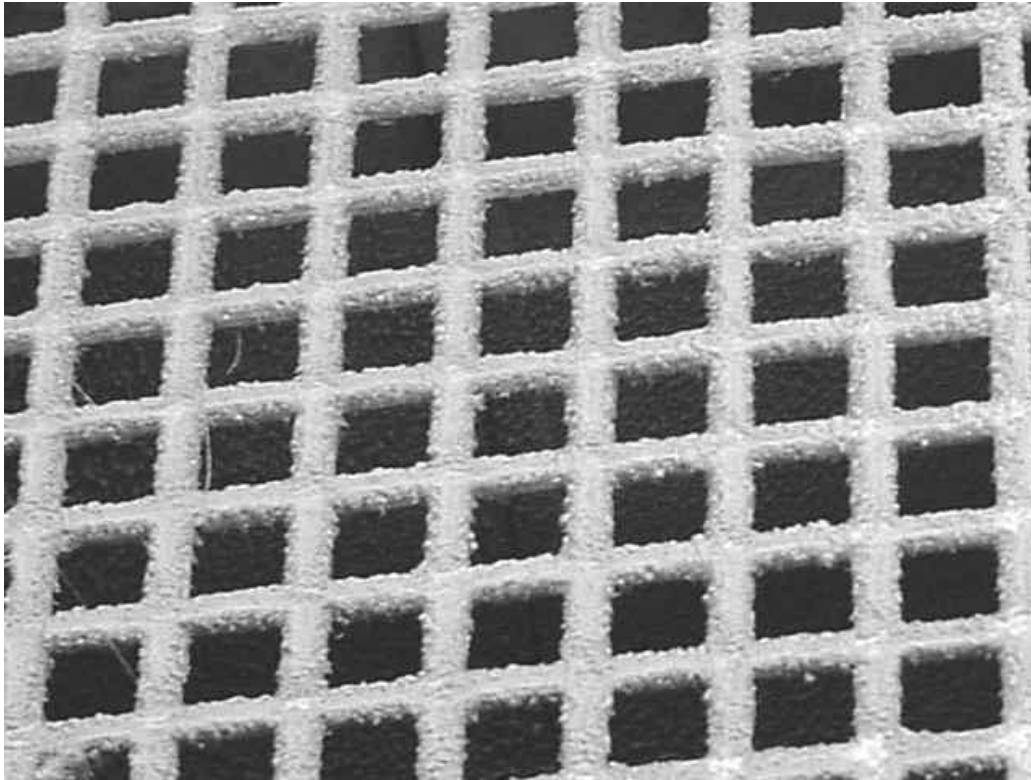
**Picture 15**

A number of exhaust and return vents in classrooms, restrooms and portable air conditioner filters were noted with accumulated dust (see Pictures 15 & 16). If exhaust vents are not functioning, backdrafting can occur, which can re-aerosolize dust particles. In addition, these materials can accumulate on flat surfaces (e.g., desktops, shelving and carpets) in occupied areas and subsequently be re-aerosolized causing further irritation.

**Accumulated Dust on Exhaust Vent Grill**

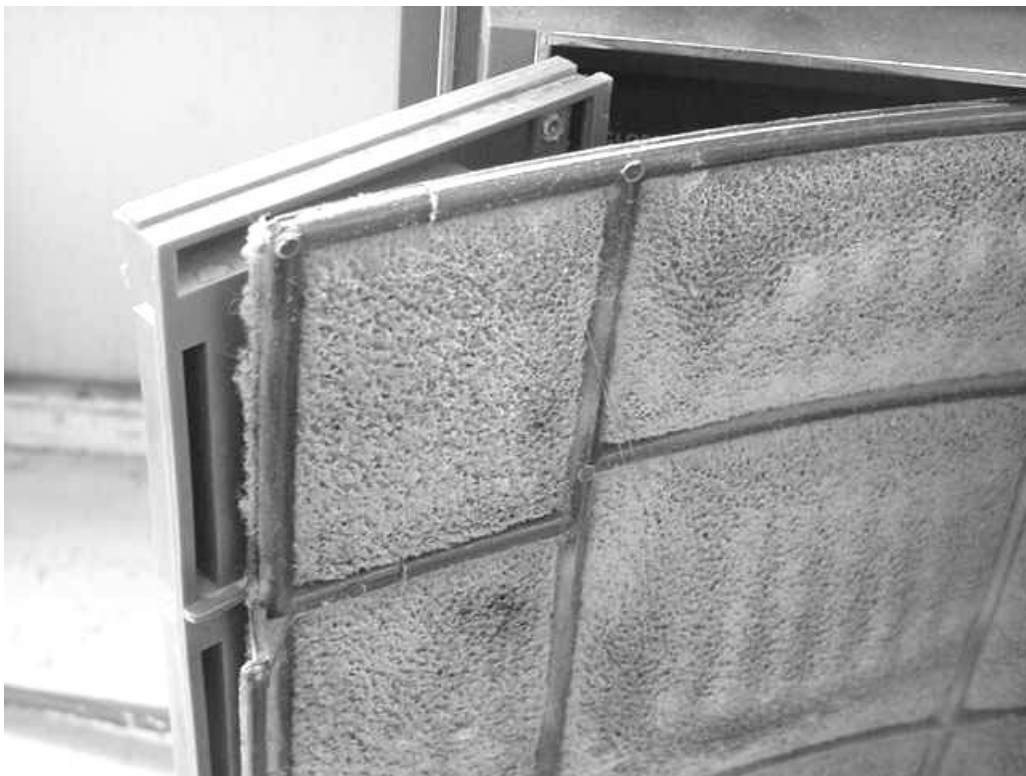
**Picture 16**

**Accumulated Dust on Air Conditioner Filter**
